Beautiful But Delicate

Why seal the surface with BROMOCO CT7571W

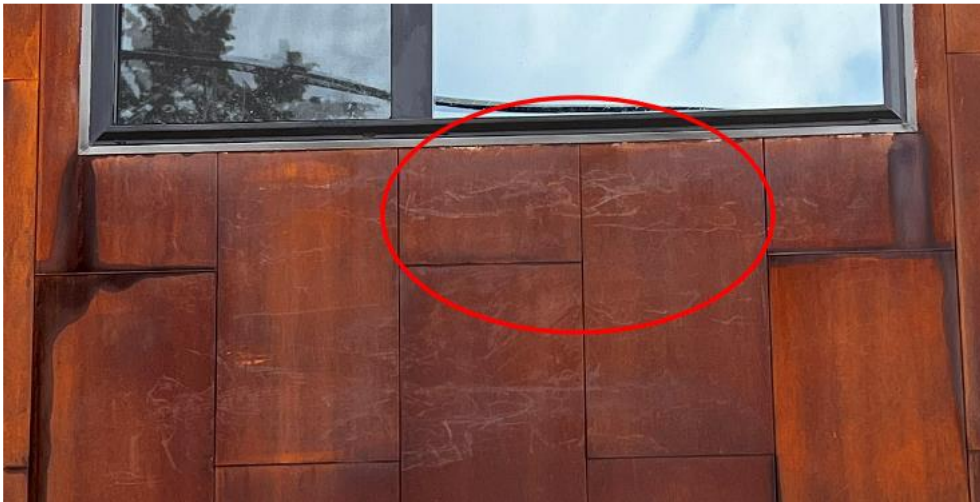
The picture below shows how the patina has been damaged by the window cleaners boot tips.

The contractor has contacted us as they have been unable to remove the scars in the patina.

Also, you can see that the accelerator that was used has not been fully removed and neutralised and is leaching out from the gaps in the panels and window frames (Dark Wet areas). This has caused the surface to flake and over time may cause more serious damage within the panel gaps.

It is essential that any accelerating processes are fully neutralised and rinsed off, Our **ERW-BD** water based biodegradable solution will neutralise acids, remove oils and contaminants from the surface.

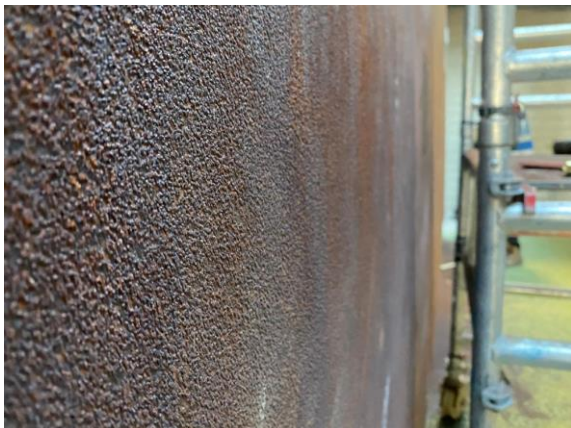
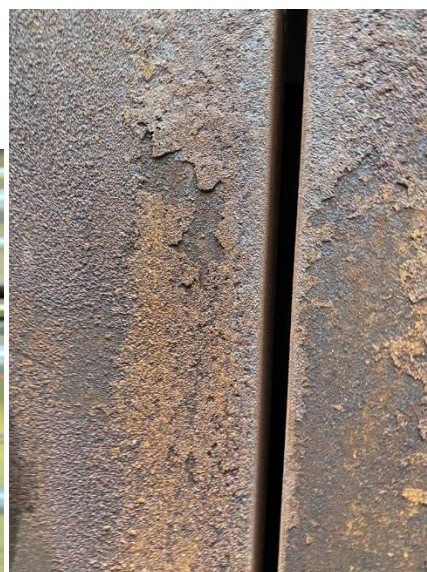
(Below shows the long term effect of not neutralising the surface)

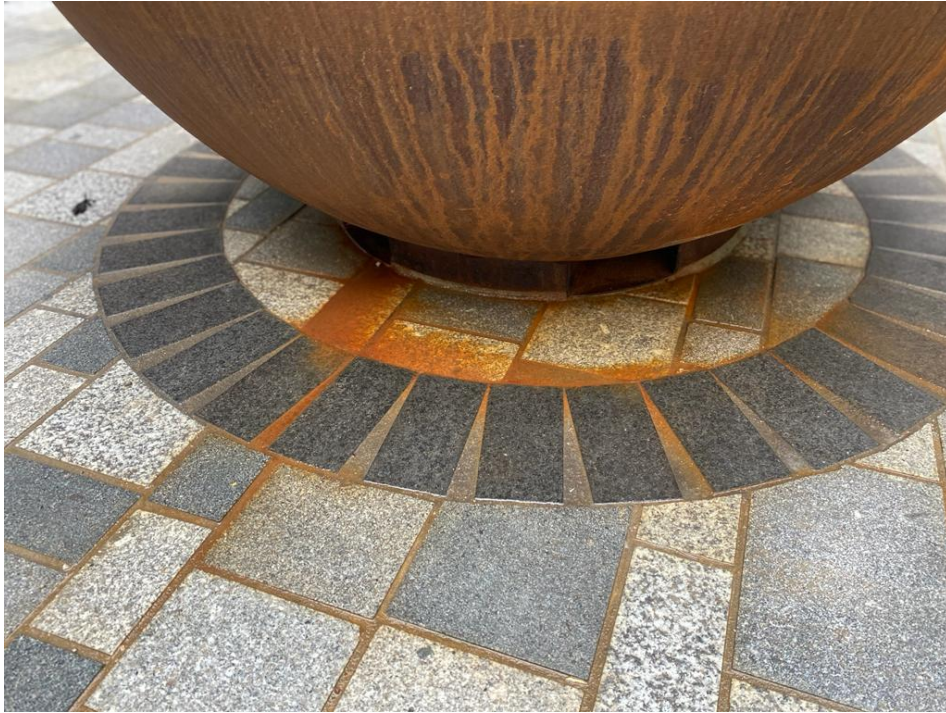
Run off is probably the first main reason for sealing the finish as surrounding areas become stained very quickly and require regular washing and acid cleaning. **CT7571W eliminates run off.**

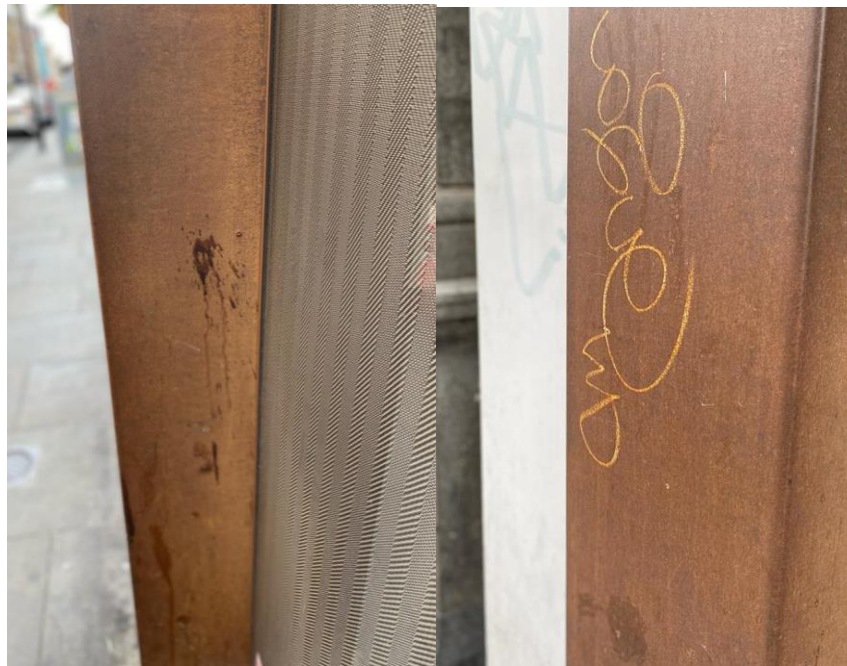
Graffiti and bird droppings are impossible to remove without marking or disturbing the patina.

BROMOCO CT7571W leaves an easy clean solvent resistant easy clean finish, normally only requiring soap and water without disturbing the patina.

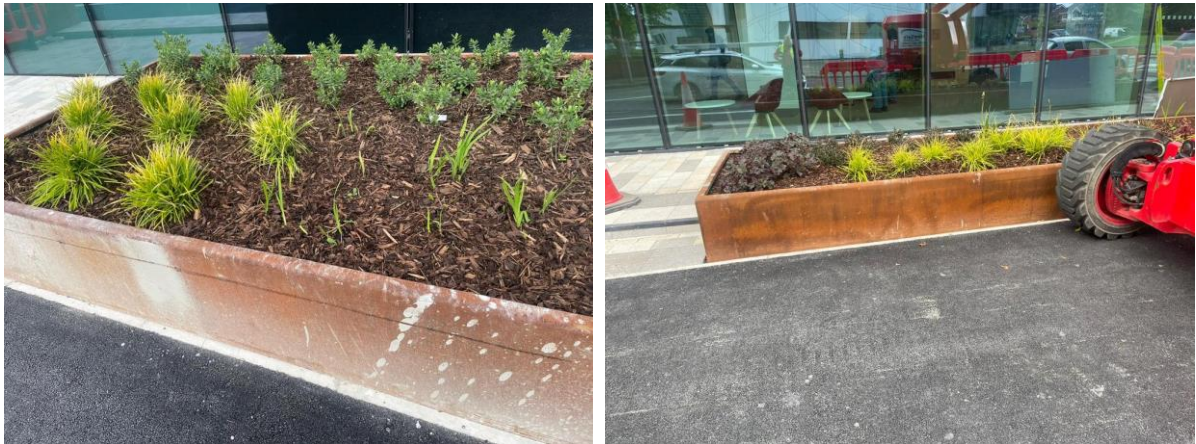
All too often weathering steel elements are installed while construction is ongoing resulting in contamination of the patina that can be almost irreversible such as concrete splashes and other building materials as well as impacts from construction vehicles.

BROMOCO CT7571W will protect against all these elements and should be applied as soon as the installation is complete.

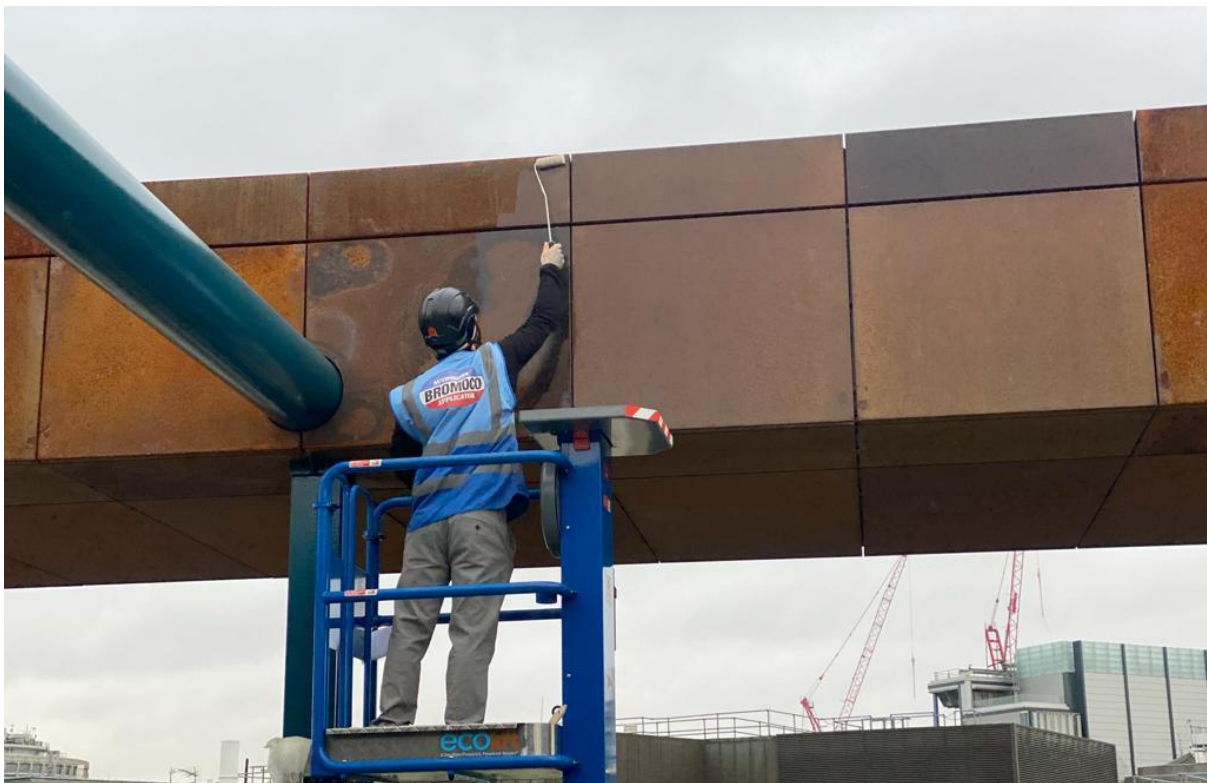
Repairing this is complex and time consuming, however **BROMOCO Network** applicators are skilled at repairing and restoring and sealing patina that is damaged in this way.
